Diving For Fun

PASSES INSPECTION - Here is your Visual Plus Inspection Report! Your safety is our first priority, so we have used Visual Plus, the state-of-the art, non-destructive eddy current testing device, as part of your cylinder's visual inspection. Unlike traditional inspections, we do not rely upon the naked eye alone to detect problems in the neck thread area that might affect the integrity of your cylinder - even though such problems are statistically rare. The trace lines record the inspection of the threaded neck region of your cylinder by Visual Plus and indicates that it is in good condition. Remember your cylinder must be inspected visually on a periodic basis according to government established guidelines. For your own protection, experts recommend more frequent inspections if your cylinder is in heavy service or is damaged during use. Ask us!

PSI VISUAL CYLINDER INSPECTION EVALUATION FORM

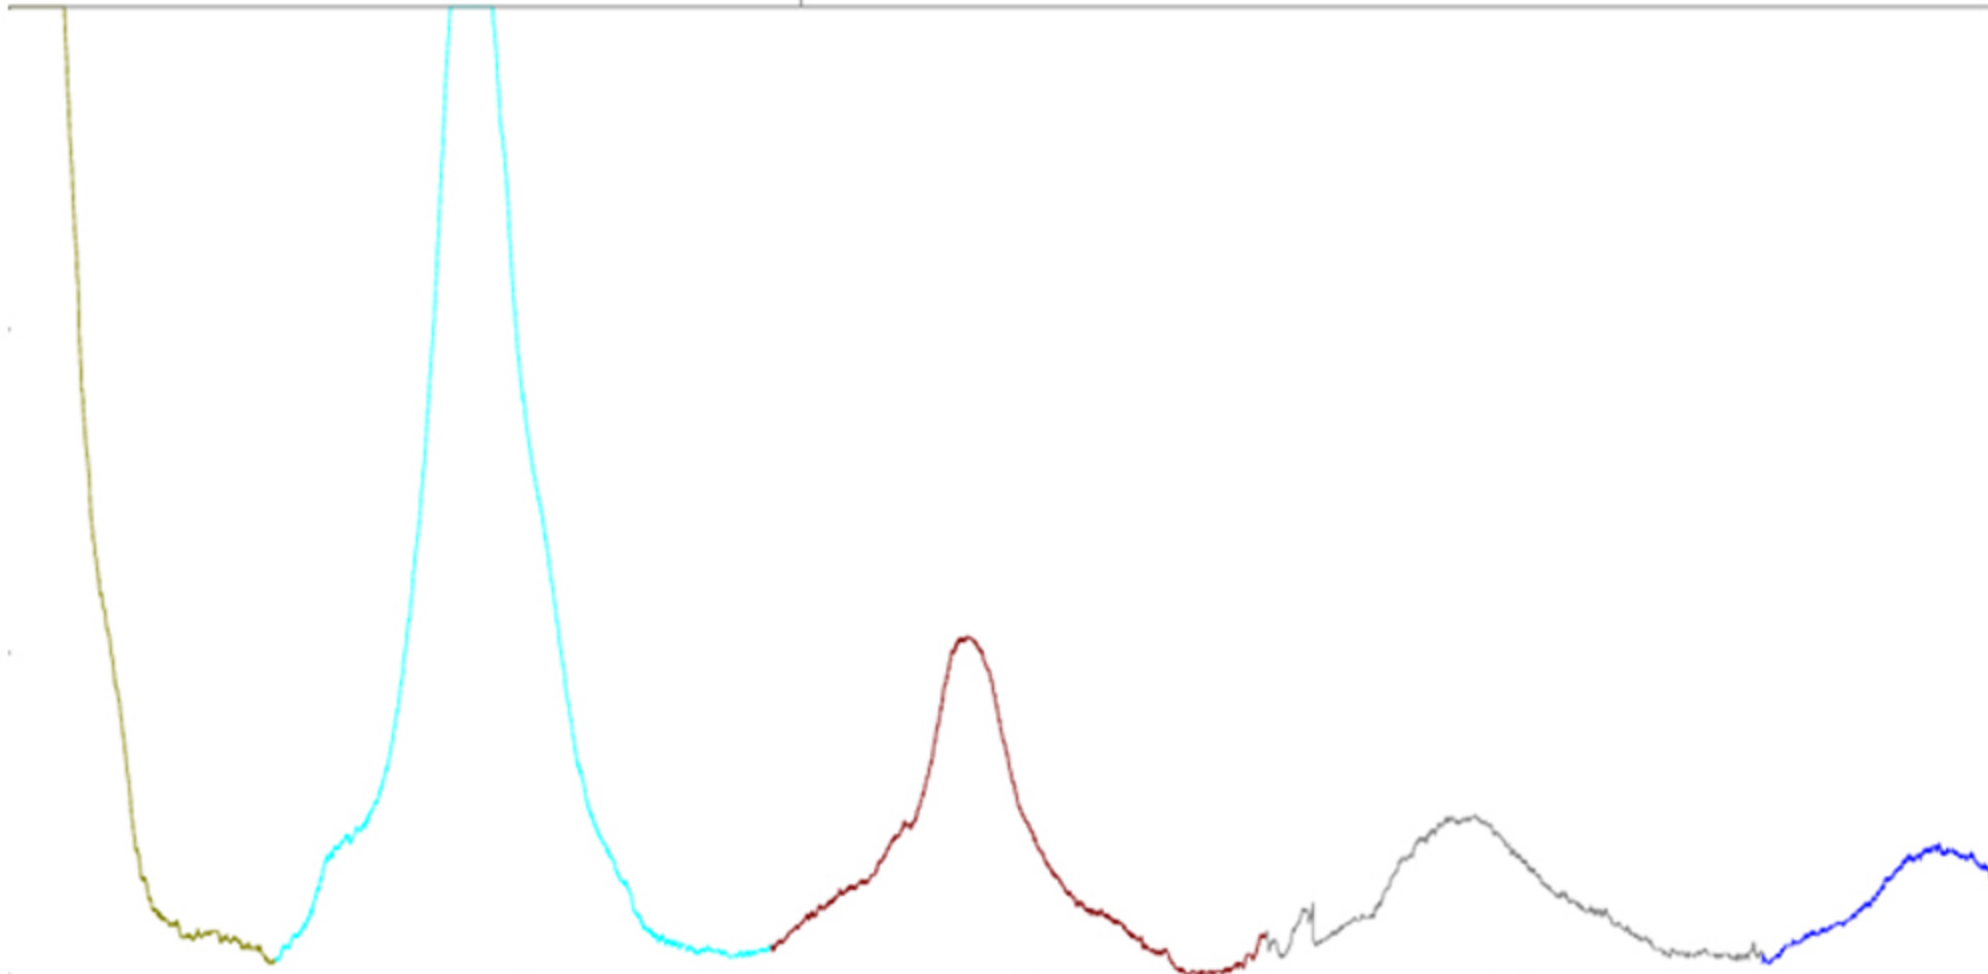
Probe: SCUBA #1 (Serial# 9790); (Cal.Std. Serial# 1211); Cal Standard Crack: 13" wide, 170 high, 497 baseline @ 157.76kHz

Analysis Results: Found 0 cracks in recorded data that are at least 3 threads long.
Please verify analysis accuracy by viewing results and performing visual inspection.
